ASPHALT SHINGLES PREVAIL IN AMERICA

UNDERSTANDING THE NATURAL AGING PROCESS OF ASPHALT SHINGLES

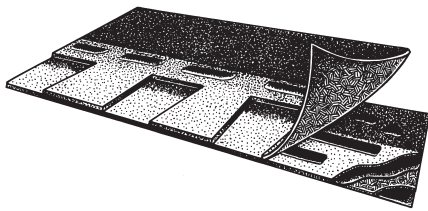
Laminated shingles consist of two or more layers bonded together, giving them added dimension for a shake-like appearance.

3-tab shingles are made with a single layer of fiberglass mat.

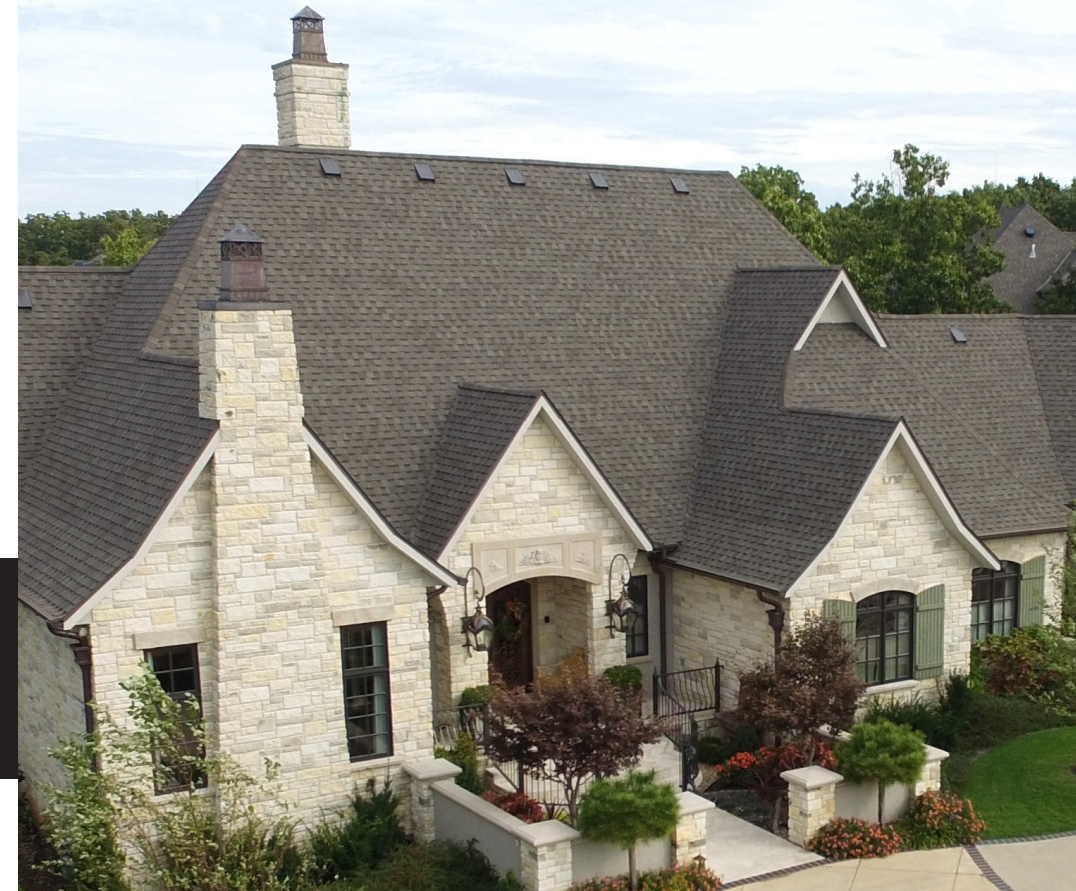
HOW TO READ YOUR ROOF

NORMAL AGING	IN NEED OF REPAIR
Curling	Open blisters
Surface cracking	Cracks visible through the fiberglass or organic mat
Closed blisters	Exposed asphalt due to granule loss
Algae stains	
Slight granule loss

Asphalt shingles will begin to age as soon as they are applied to your roof. Minor curling, surface cracking, blisters, algae stains, granule loss and buckling are all signs of aging.

Curling is a common phenomenon in some shingles and is not a defect. It is natural for asphalt to age and asphalt layers to shrink with time. This shrinkage may result in the slight curling of the edges of the shingle.

While minor cracks may not be noticeable from the ground, you might spot them while hanging your Christmas lights. Intense heat from the sun often allows protective asphalt oils to deplete, causing minor cracks. Keep in mind that these normal weathering characteristics are not cause for alarm as long as your shingles are still performing their intended purpose of shedding water. Cracks that penetrate through the fiberglass or organic mat should be investigated.

In moist, humid areas, dark brown or black patches may appear on roofs. These streaks result in a dirty rooftop, often more visible on lighter-colored shingles. This naturally occurring stain is caused by algae growth and will not affect your shingles' ability to shed water. Algae discoloration should not be confused with moss or tree droppings, which typically produce only localized discoloration.

Since extra granules are used in the manufacturing process, some granule loss is to be expected during the early years of your roof. Other factors, such as foot traffic, hail, snow or brushing tree limbs, may cause loose granules. However, exposed asphalt due to granule loss is a reason for concern and requires immediate attention.

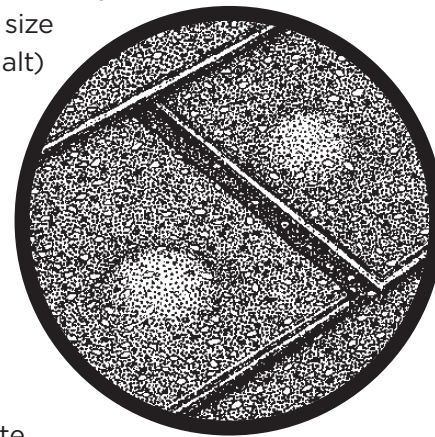
BLISTERS

Occasionally, naturally occurring small, circular raised areas known as blisters may appear on your roof. These pockets may vary in size and be open (exposing the asphalt) or closed. Blisters are often a direct result of underventilated attics or excessive use of plastic cement. Closed blisters are not a reason for concern as long as your shingles are still performing their intended purpose of shedding water. However, open blisters do mean asphalt is exposed and immediate attention is required.

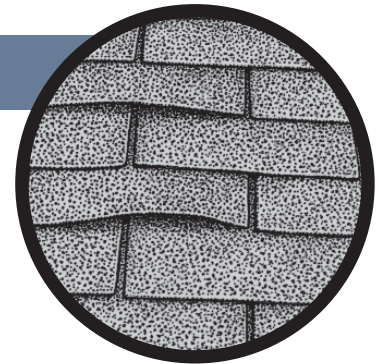
BUCKLING

While not technically a sign of aging, a distortion of shingles known as buckling can occur months after original application. Lack of adequate attic ventilation can increase the moisture content of the decking material. This may cause expansion and movement of the wood deck which can lead to buckled shingles.
